Las Huertas Creek Photos

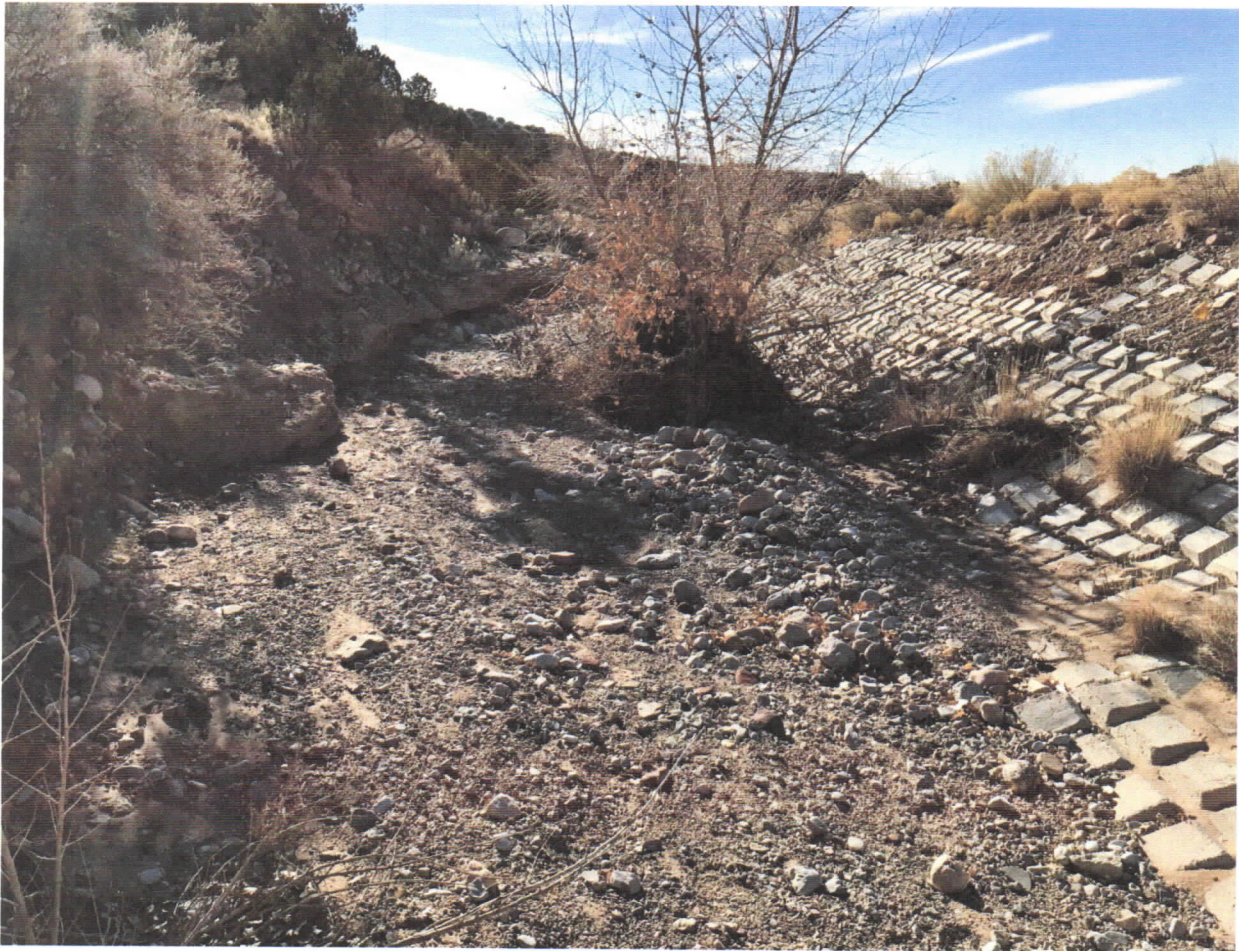
2011 Engineering Report Map Hot Spot #7

The 2011 Engineering Report identifies this pipeline crossing Las Huertas Creek in front of the tree in the creek bed as HOT SPOT #7 on their map. We believe Tetrattech designated this location as a HOT SPOT because this location in the creek is posing a risk to this High Pressure Natural Gas Liquids (NGL) pipeline. The NGL pipeline crosses from the left side of the creek where there is NO concrete block protection.

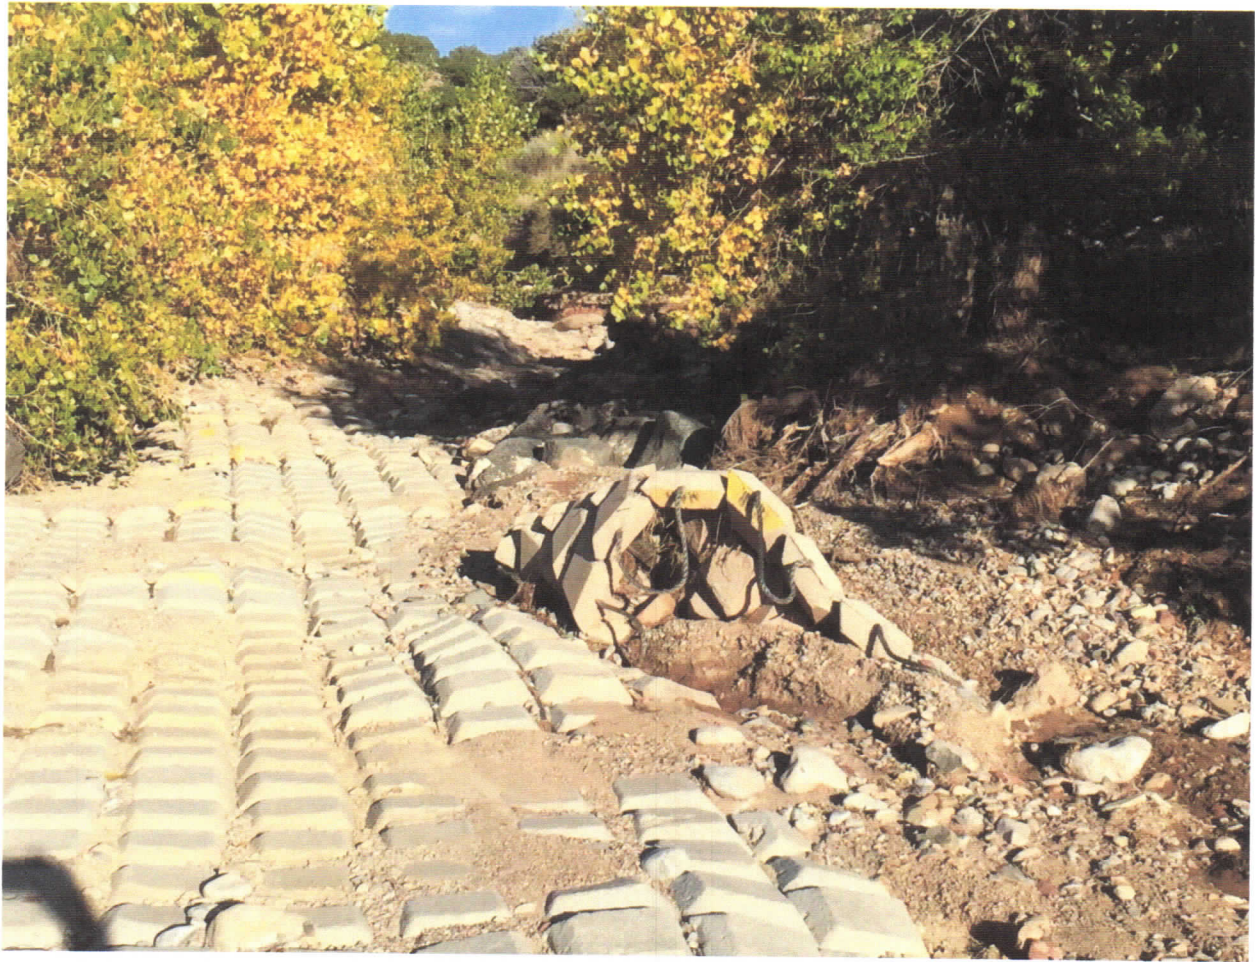
Concrete Block Pipeline Protection in Las Huertas Creek

Notice the damaged concrete block blanket. We were told that this damage occurred after one rain event.

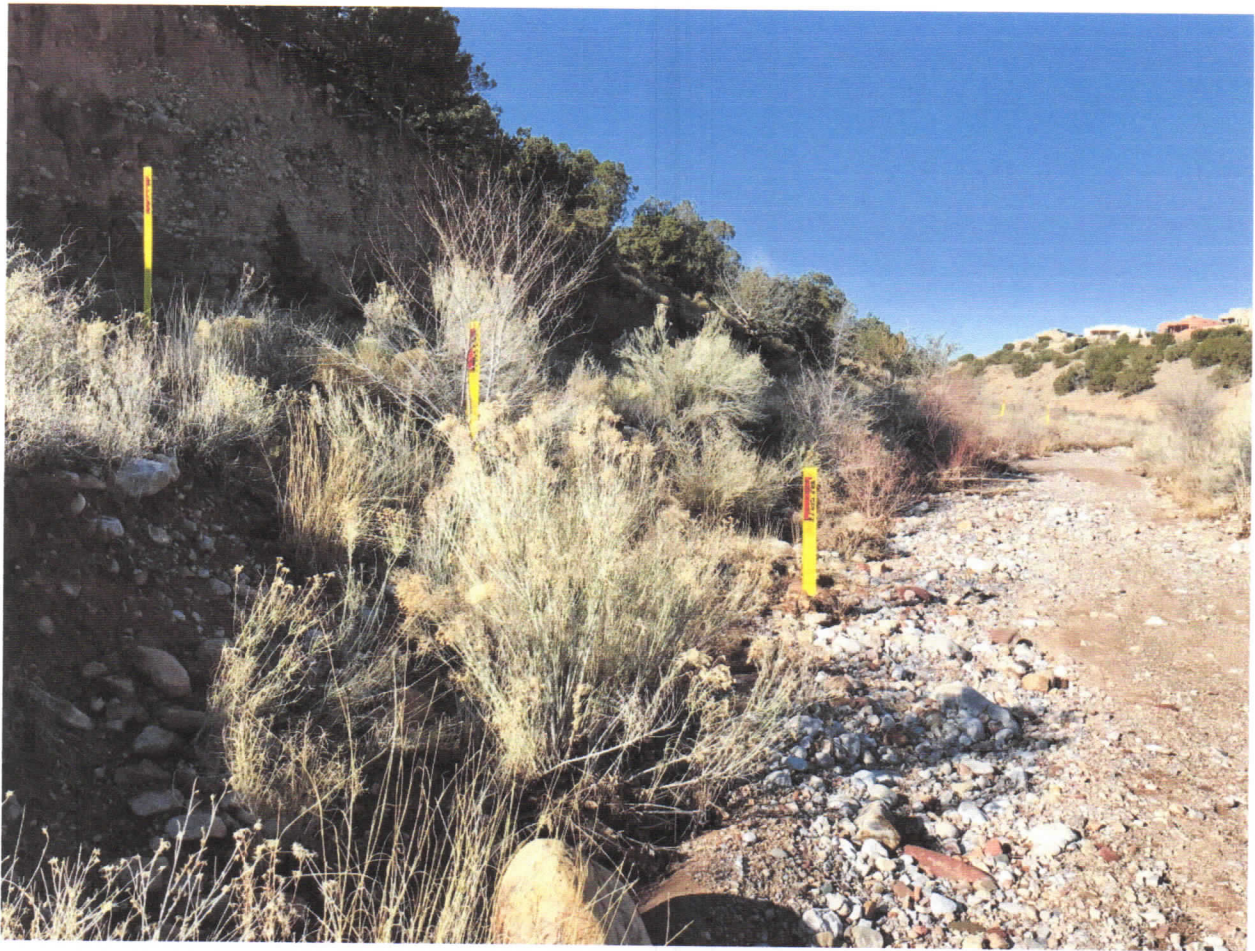
Three High Pressure Flammable Pipelines Entering Las Huertas Creek

The 2011 engineering report recommendation #3 said to install gabions at this location to protect these pipelines. There is no evidence that recommendation #3 was ever implemented.

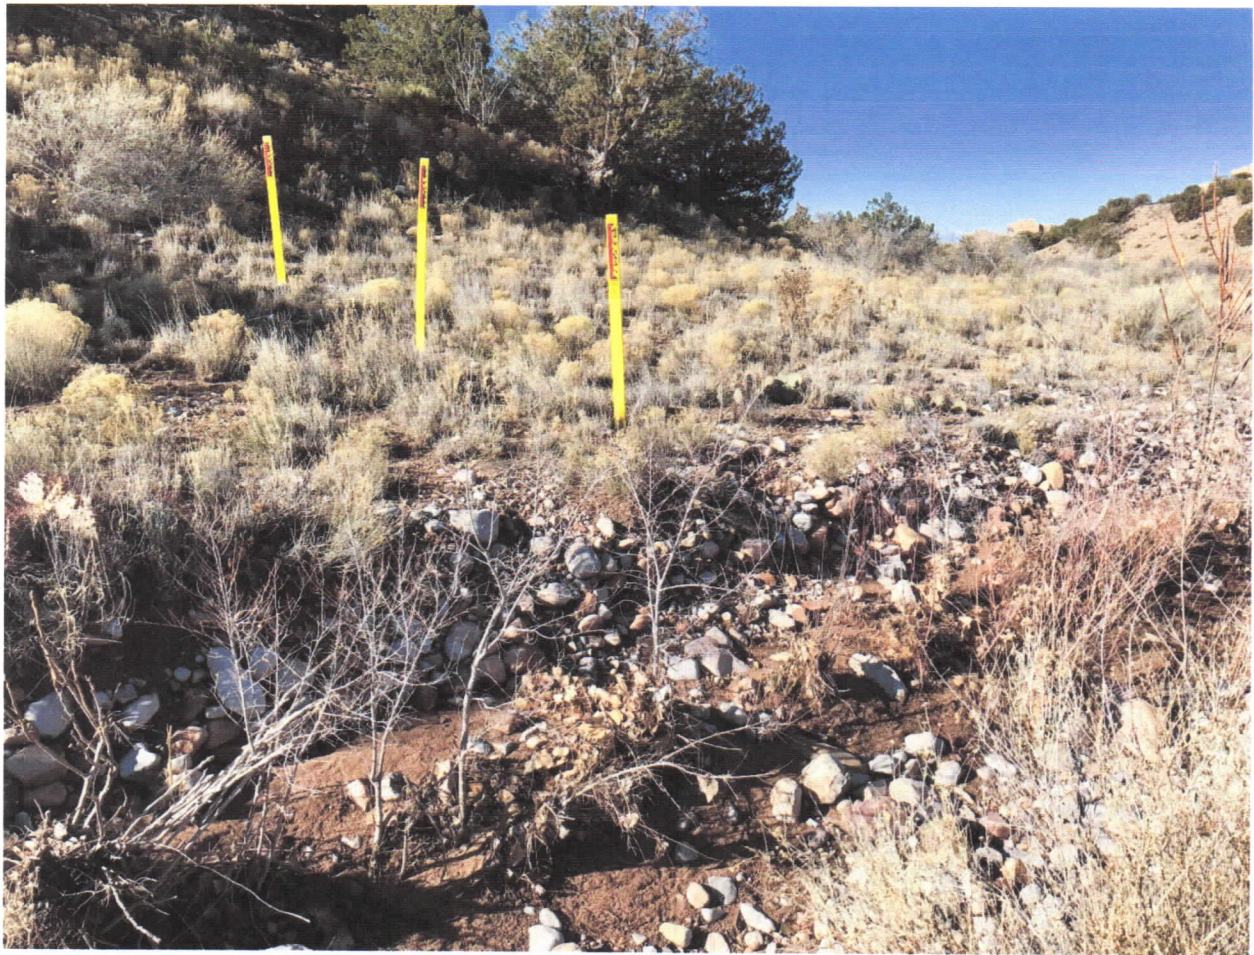
Three High Pressure Flammable Pipelines Entering Las Huertas Creek

The 2011 engineering report recommendation #5 said to “extend natural ground control structure with buried concrete each side” at this location to protect these pipelines. There is no evidence that recommendation #5 was ever implemented.
